Preproduction requests

Request for January/February

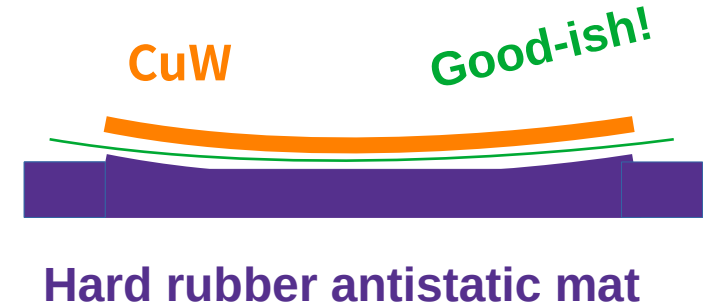
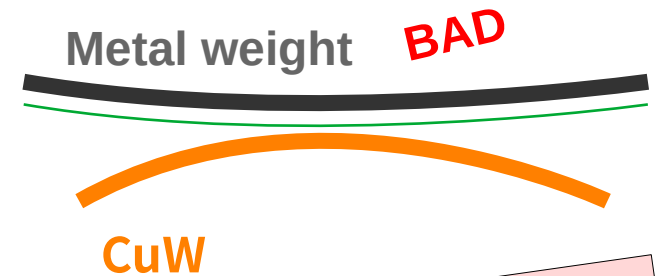
- Hole-neighborhood cleaning. **All good!**
- **Edge delamination**
 - Cause: Anti-alignment of Kapton and baseplate curvatures
 - **Prevention:** **Flexible** surface during curing. Enforces good contact across entire Kapton surface during curing
We can artificially generate this issue by changing curing configuration!
 - **Recovery:** manually adding small quantities of glue post-mortem into gap confirmed to *not* introduce flatness issues!

Full solution would require better equipment (under construction)
